MISCELLANEOUS PAPER S-73-19

CONDITION SURVEY, CASTLE AIR FORCE BASE, CALIFORNIA

P. J. Vedros

April 1973

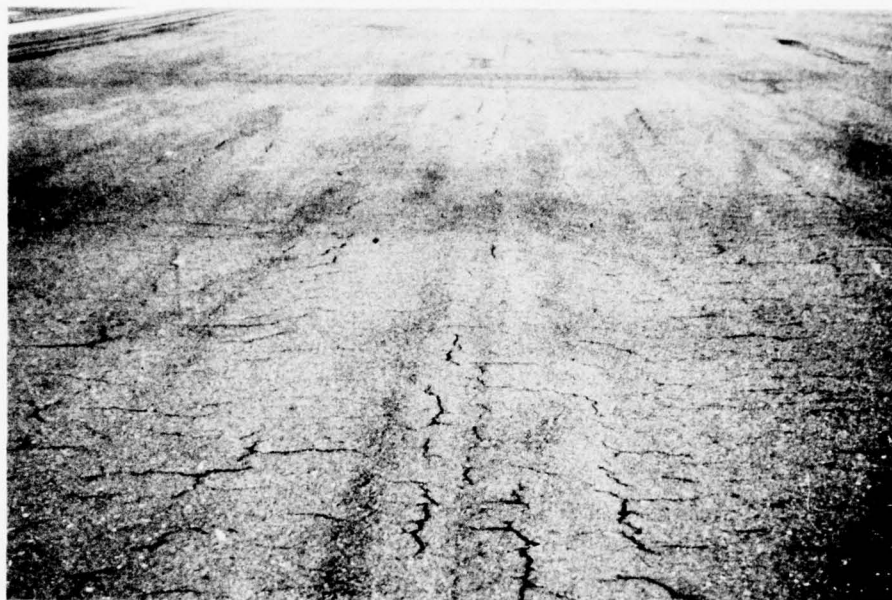
sta 77+00 to 118+00 had been heater-planed and overlaid in 1969 due to roughness of the surfaces, and the repair appears to have corrected the problem. The AC surface near the edges of the runway (photo 1) contained a considerable number of shrinkage cracks. The 18-in.-thick PCC pavement of the first 1000 ft of the northwest (12) end was in excellent condition, with no more than 3 percent of the slabs containing a major defect. The predominant defects on the runway pavement were longitudinal and transverse cracks. A summary of the runway defects is presented in table 5.

Photo 1. Condition of AC surface on edges of runway
at northwest end

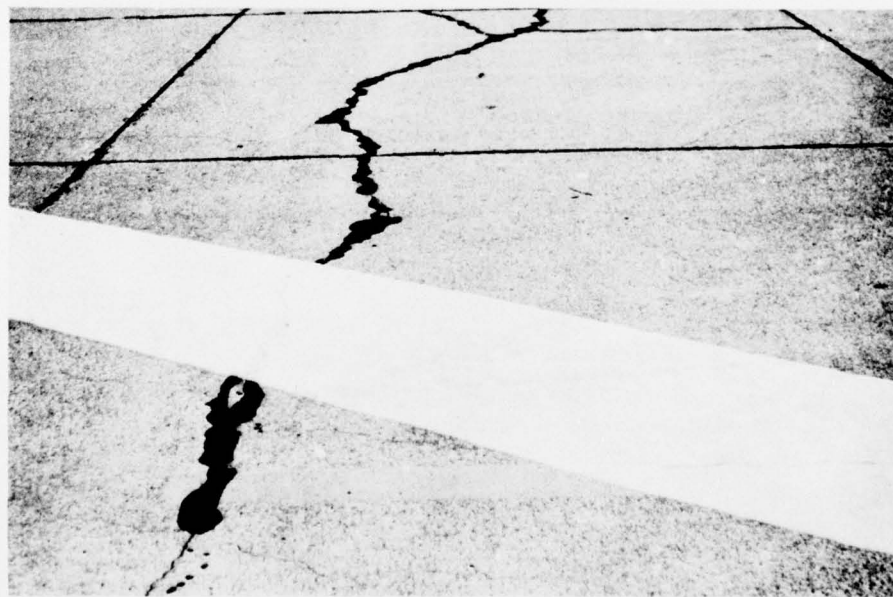
Photo 2. Cracking in 18-in. PCC of taxiway 1

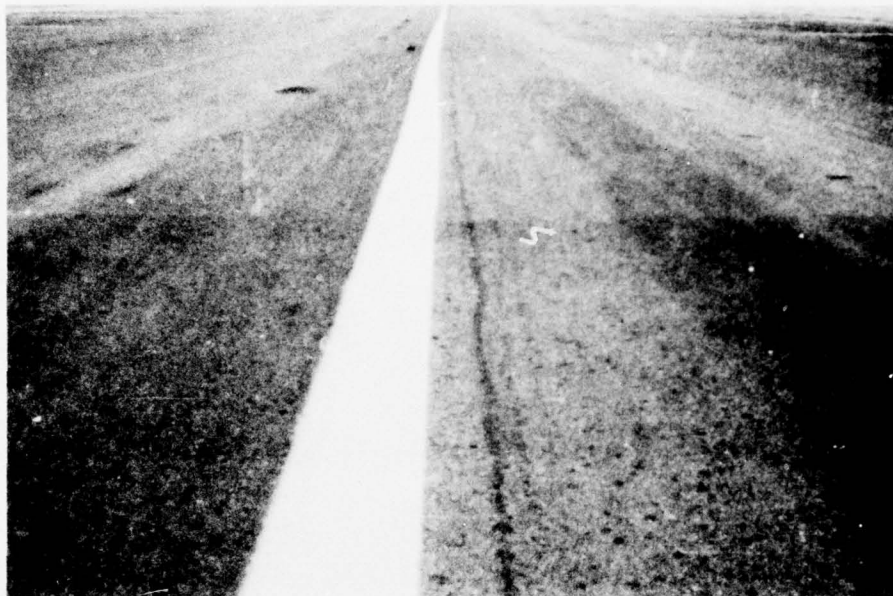
Photo 3. Flexible pavement portion of taxiway 1. Note resealed area adjacent to center line

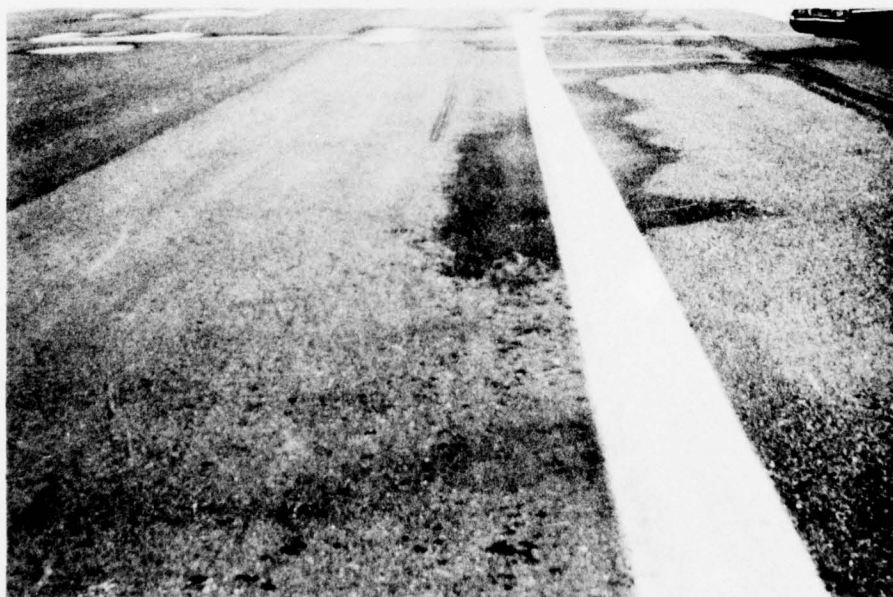
Photo 4. Taxiway 1 at northwest end. Note birdbaths in upper part of photo

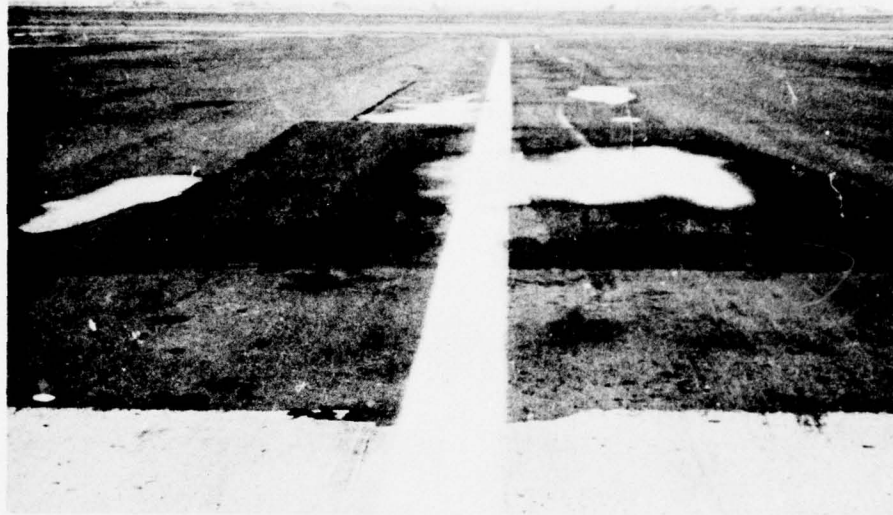
Photo 5. Densification in taxiway 10 in wheel paths
of B-52 aircraft

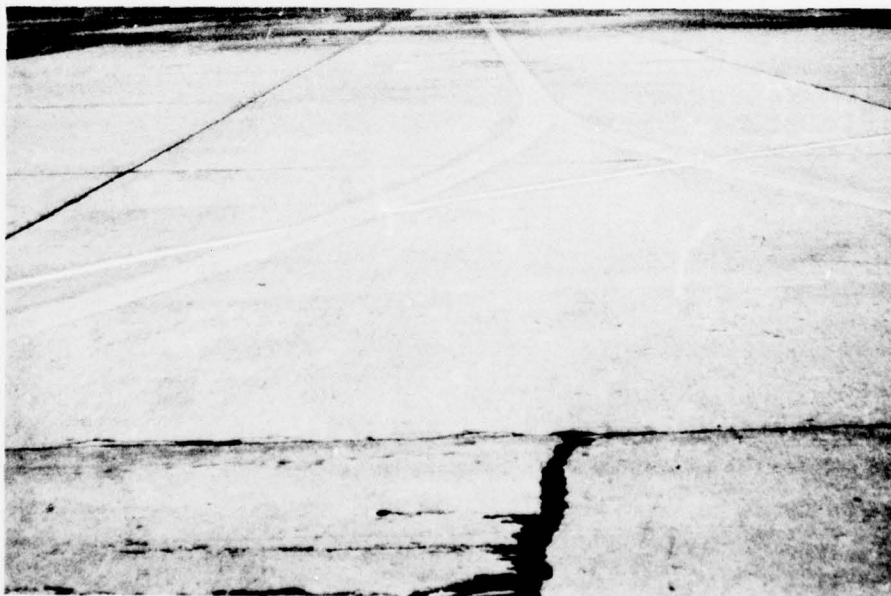
21. The parking stubs were generally considered to be in a poor to failed condition in those areas where the 11-in.-thick pavement is still being used. A number of slabs in the center lanes of the stubs have been replaced with 21-in. PCC (photo 6). Very few defects were found in the replaced slabs of the stubs that were inspected (Nos. 12-19).

Photo 6. Replaced slabs in center of stub parking area.
Cracked pavement in foreground is 11-in. PCC
